# **Avoiding that shrinking feeling: adopting a chemically unstable material for conservation**

**Andrew Pearce**  
**Australian War Memorial**

**Abstract:** *During 2003 the Australian War Memorial undertook conservation work on two large aircraft, a DAP Beaufort and an Avro Lancaster. This work included the repair and re-covering of control surfaces with doped fabric. Physical evidence present in the Memorial's aircraft collection and the written and verbal testimony from a number of individuals involved in the operation and re-covering of vintage, fabric-covered aircraft has strongly indicated that cellulose butyrate (a doping compound used since the mid 1950s) continues to contract over the long term, resulting in the damage and destruction of doped fabric surfaces and their underlying framework. This paper discusses the use of cellulose nitrate based doping compound which, while considered by many to be unstable, is present on a number of the Memorial's First and Second World War aircraft in extremely good condition. Discussion of the fabric-covering process deals with the processes involved and the training of members of the large technology conservation team in what is a l

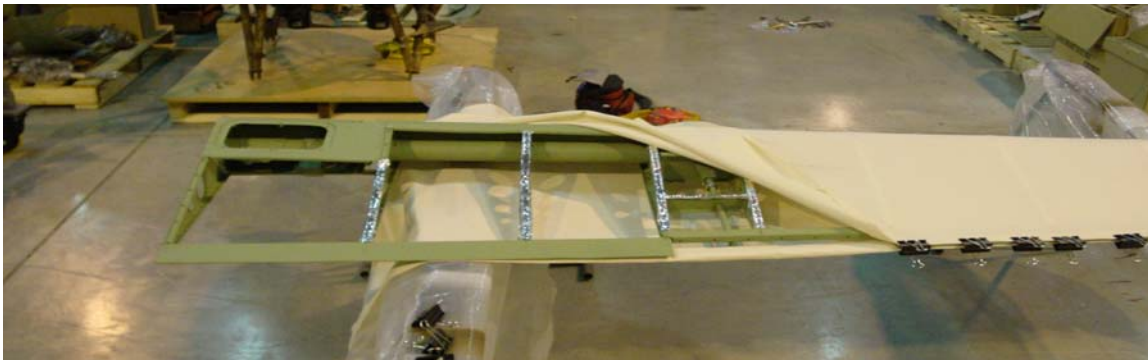
**Figure 3: Placement of cotton bag over aileron**

Following the application of the aluminium foil, the cotton fabric was cut to produce an oversize covering for the aileron and was clipped into position along the trailing edge with edges rolled under. The trailing edge seam of the aileron fabric was then stitched, using waxed linen thread in a modified running blanket stitch. For aviation purposes, running blanket stitch is knotted at regular intervals. This prevents any chance of the entire seam becoming unraveled should localized damage occur to the seam.

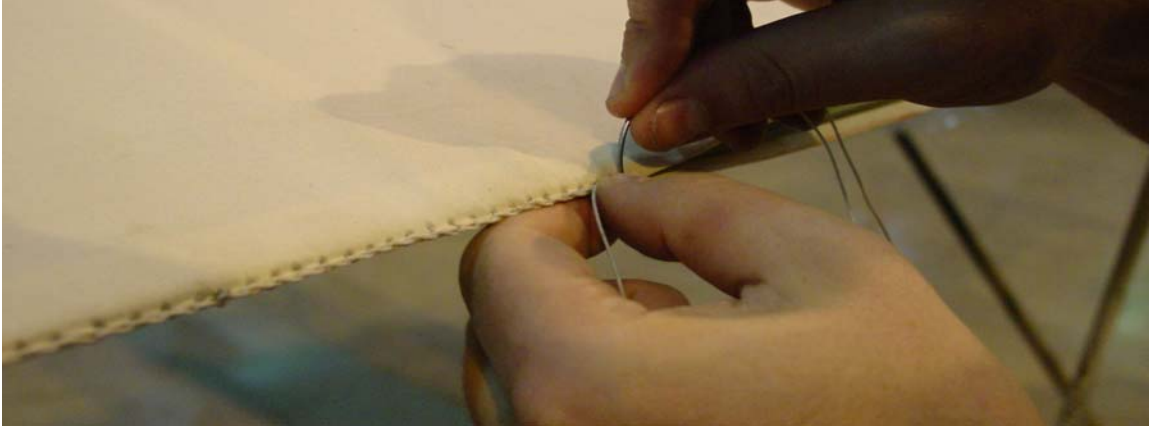
**Figure 4: Stitching of trailing edge seam**

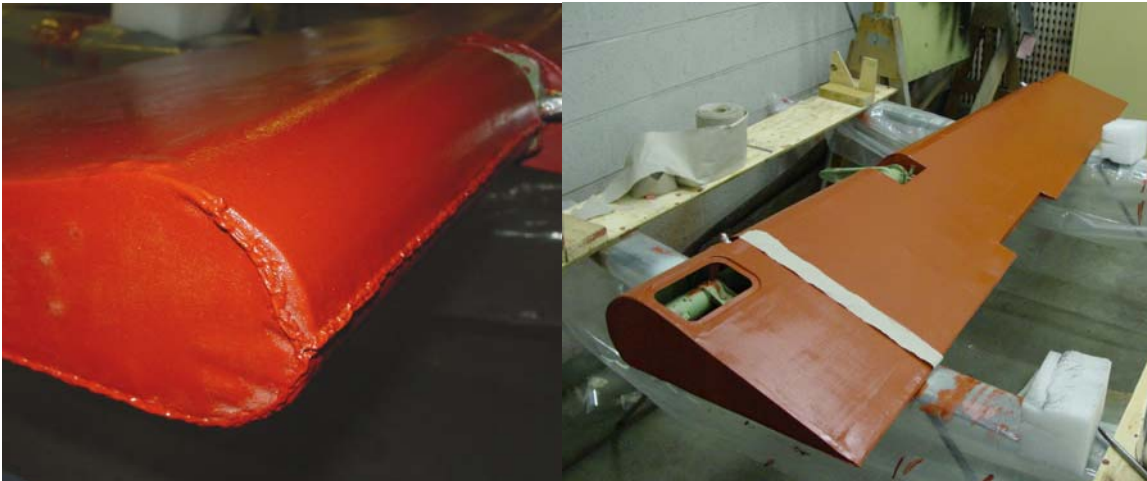
**Figures 5 and 6: Well saturated doped fabric surface and the application of rib strips**

Following the neat sewing of all external seams, the fabric surface was given its first coat of tautening dope at approximately 50:50 v/v dope and thinners. Following the initial application and drying of this coat the surface was sanded smooth with 360 grade emery paper in preparation for the subsequent dope layers.

After the application of about seven layers of dope the surface was satisfactorily tight, the fabric weave was well filled with dope and the surface was smooth ready for the application of rib tapes. These tapes are strips of linen which follow the line of the ribs within the aileron and are used for local reinforcement of the fabric surface. Once the rib tapes were adhered in position using dope and had dried, the laborious process of using waxed floss to stitch the doped fabric surface to the ribs began.

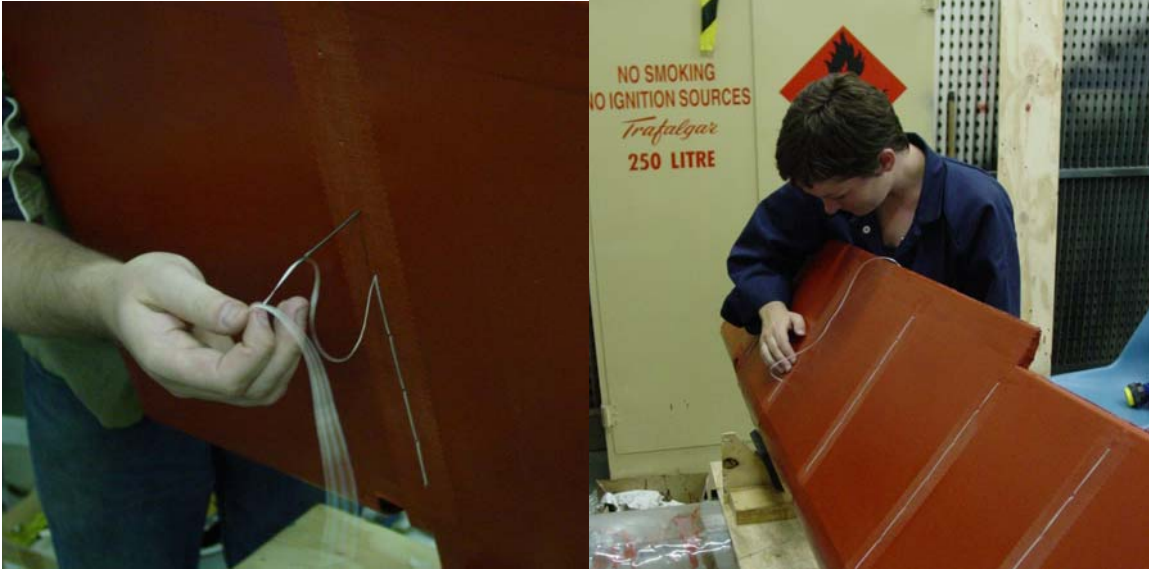
**Figures 7 and 8: Rib stitching**

After the rib stitching was complete, a second run of rib tapes was applied over the stitching and the surface was coated with layers of dope until the same filled and smooth surface was achieved.
